USATECOM PROJECT NO. 4-5-7496-01, -02, -03 RDT&E PROJECT NO. NONE AD

Final Report of Test
"MILITARY POTENTIAL TEST (CATEGORY II)
OF JUNGLE CANOPY PLATFORM SYSTEM"

August 1965

DEPARTMENT OF THE ARMY
UNITED STATES ARMY AVIATION TEST BOARD
Fort Rucker, Alabama 36362

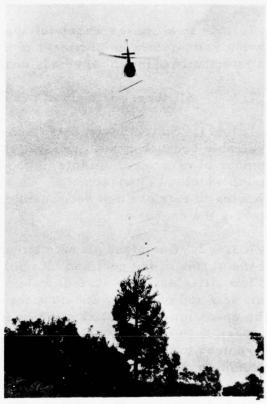
Figure 6 (left). Three nets retrieved simultaneously.

Figure 7 (right). Retrieving net. (Note cable ballast.)

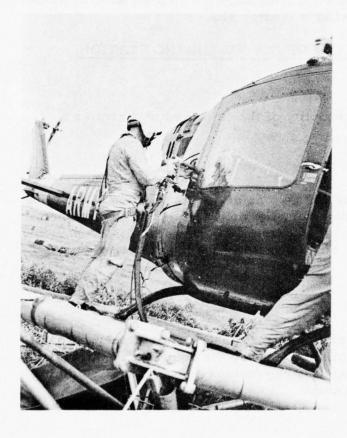
2.12.3.1. The simulated refueling operation was satisfactory. Actual refueling could not be accomplished because the refueling pump was contaminated with rust and existing regulations do not permit refu ing an aircraft with the engine running.

- 2.12.4.1. Refueling a helicopter on the platform cannot be done unless it is done with the engine operating and the rotor turning with the aircraft remaining light on the skids.
- 2.12.4.2. Refueling probably could not be performed on every installation because of instability of the platform in most cases and the likelihood

Figure 10.
Simulated refueling operation, UH-1B atop platform.

the platform would sag too deep with the concentrated load. Each installation would have to be checked individually to see whether the helicopter could be landed prior to setting up for refueling operations.

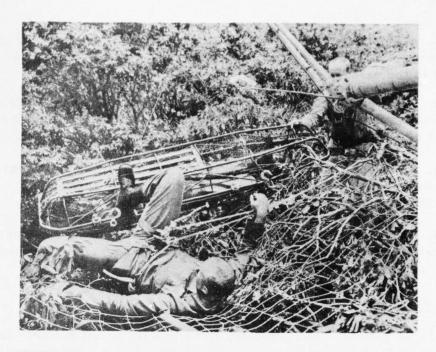
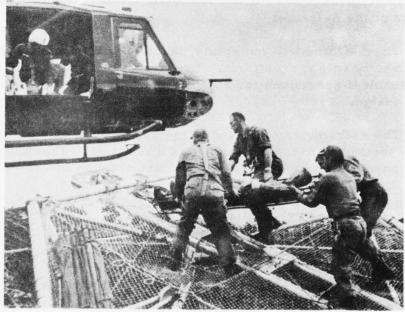
2.14.3.1. The A-frame was easily erected and the cable engaged. Total elapsed times for this operation did not exceed one minute. However, the rate of descent of the cable to the jungle floor and the subsequent ascent of simulated casualties onto the test system was slow (hoist rated at 16 f.p.m.).

Figure 11 (top). Test personnel attempting to pull simulated casualty over side of net.

Figure 12 (bottom). Loading simulated casualty onto evacuation helicopter.

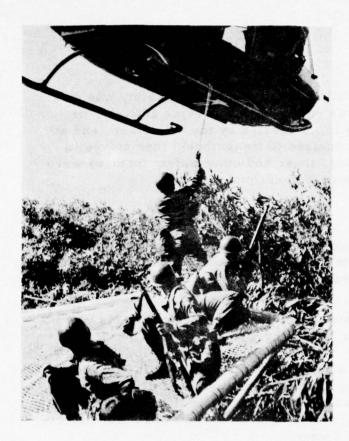
- 2.17.3.2. On another occasion a soldier standing on the nets was injured while supervising their tightening.
- 2.17.3.3. On one occasion a soldier got off the aircraft with loose coils of a safety rope hanging from his waist. A coil of the safety rope hung up on the UH-1B skid during helicopter lift-off and the soldier was carried to a height of over 100 feet before he was discovered hanging beneath the helicopter.

Figure 13.
Coil of safety rope hung up on UH-1B skid.

2.17.4.1. The test system will not be safe for infantry use until a satisfactory method is found to secure all loose equipment prior to recovery, and until a preliminary operator's and organizational maintenance manual is prepared and followed by trained personnel. The lack of an adequate means to secure the hoist cable constitutes a grave safety hazard and is considered a deficiency. The lack of a preliminary operator's and organizational maintenance manual was listed as a deficiency in paragraph 2.8.
